# Manhole Inspection Summary

Manhole # S31SS\_032MH

Insp Date: **5/14/07 9:01 AM**

**Location** Address: **327 28TH ST**

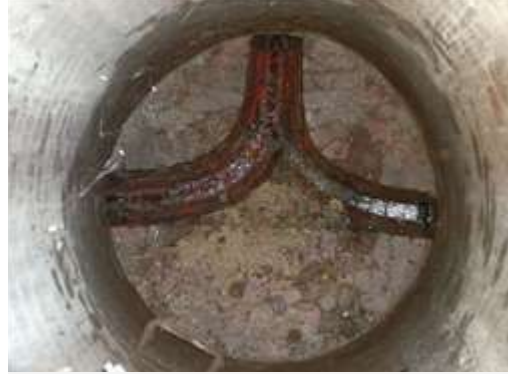
Top View

Corroded and missing steps. Evidence of surcharge - Bench debris.

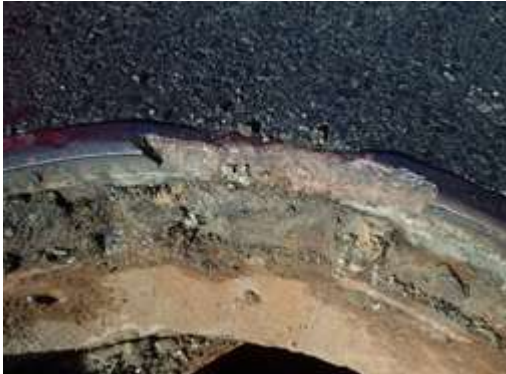
Defect

Broken frame.

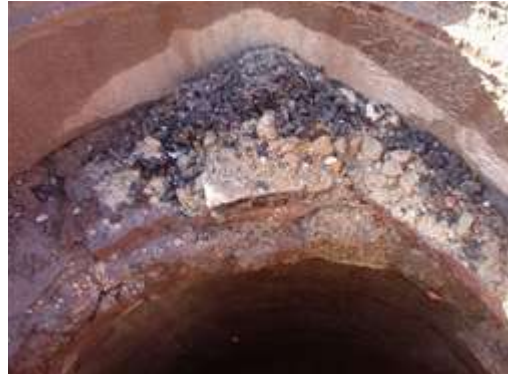
Defect

Adjustment deterioration, loose brick and infiltration.

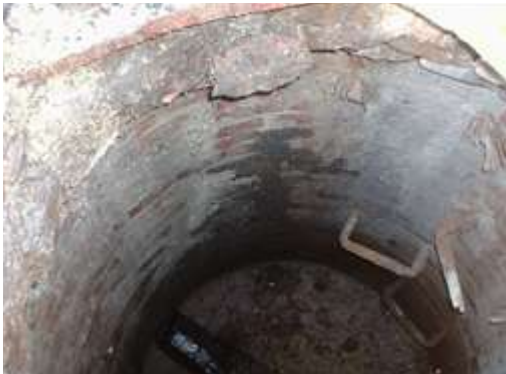
Defect

Adjustment deterioration, loose brick and infiltration. Corbel and Barrel infiltration.

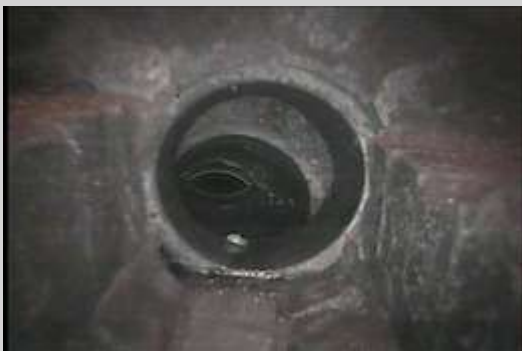
### 8 in. Circular Gravity Sewer Pipe In @ 3 O'Clock

Major offset joint.
